Hardstand Construction using DUX W155 Geotextile

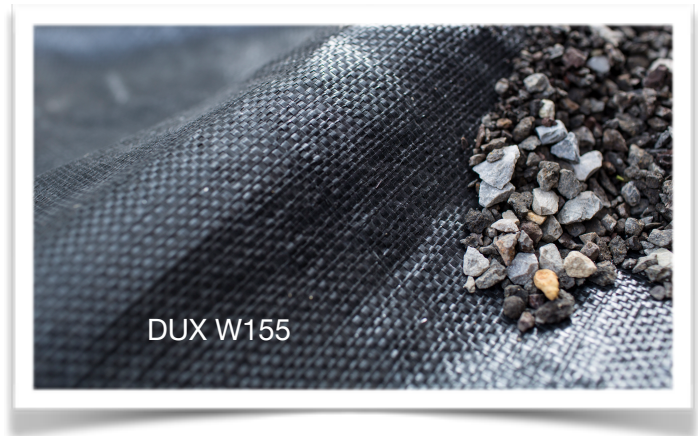
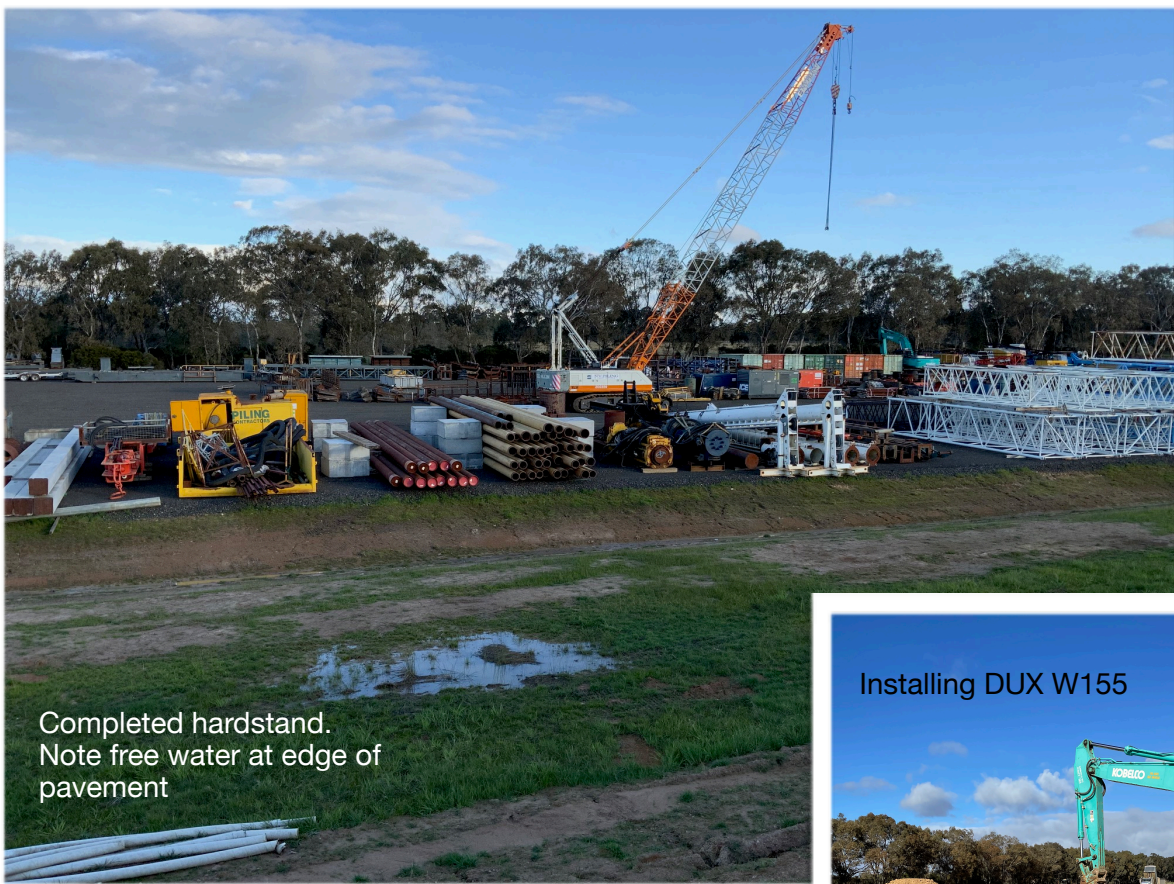
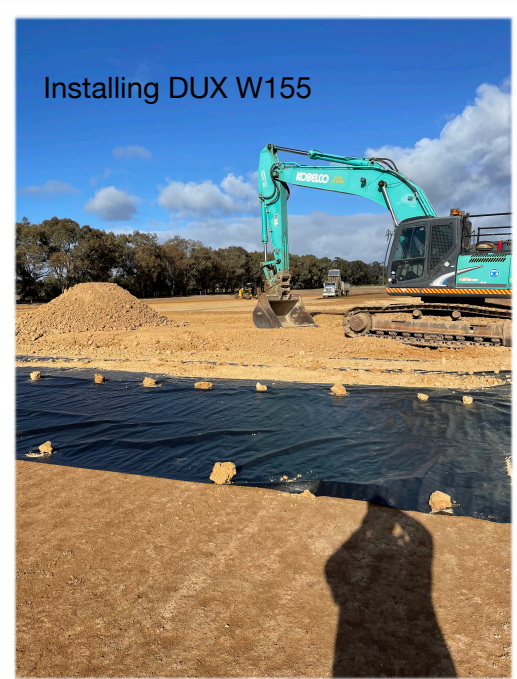
DUX W155 woven geotextiles provide the strength of a geogrid, together with the separation function of a geotextile, at a fraction of the cost. At this hardstand project north of Kilmore a suspect subgrade had failed proof rolling. W155 was installed with a capping layer of 300mm compacted soft rock, followed by 150mm of crushed rock. Subject to heavy loads of 100 tonne crawler cranes and heavily loaded semis, through the wettest winter for 25 years, the pavement is holding up well.

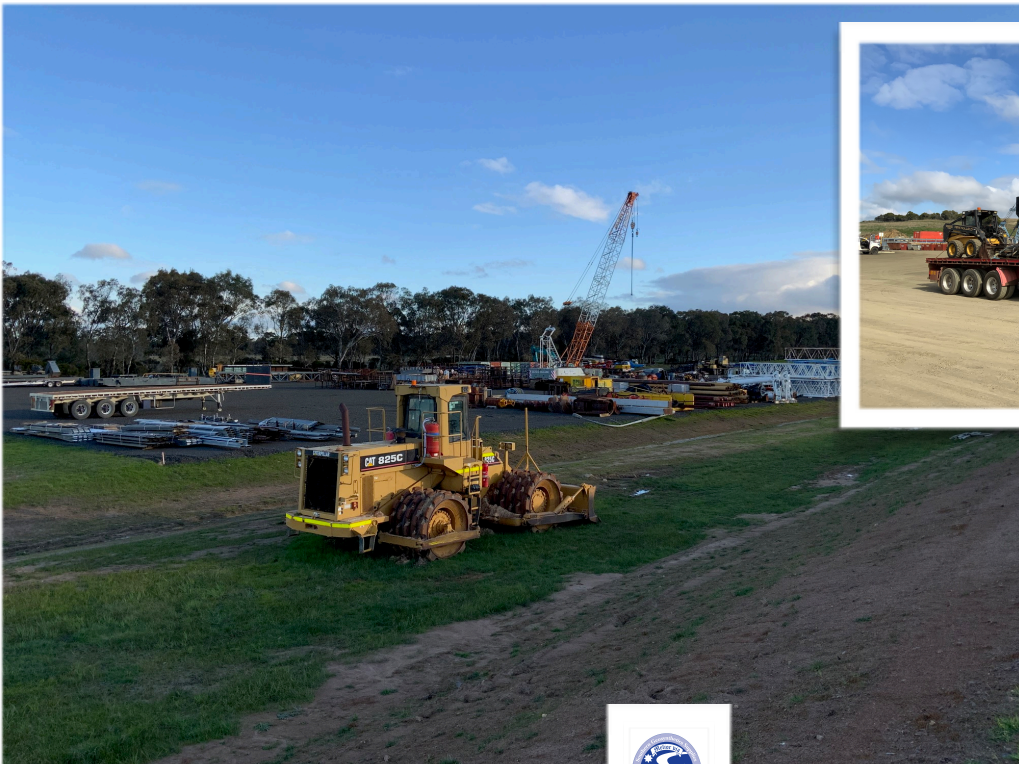
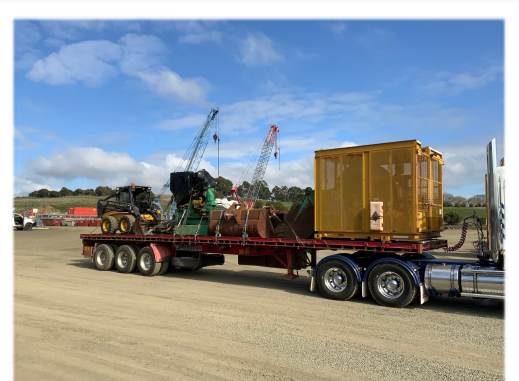
As you will see in the photo's the hardstand and access road is performing very well. Some stat's since completing in early July 21:

- Multiple OSOM loads up to GVM of 120 tonne have traversed the access road and hardstand;
- 100 tonne Crawler crane has worked and moved around the pad effortlessly;
- We have had in excess 100 semi loads delivered to this site to date since completion;
- No softies or pavement failures to date which we believe is a result of the product and advice provided by SGS.
